TECHNICAL SERVICE BULLETINS

2/24/89

ERROR CODE INFORMATION FOR ALL SOFTWARE THRU 4.00.00

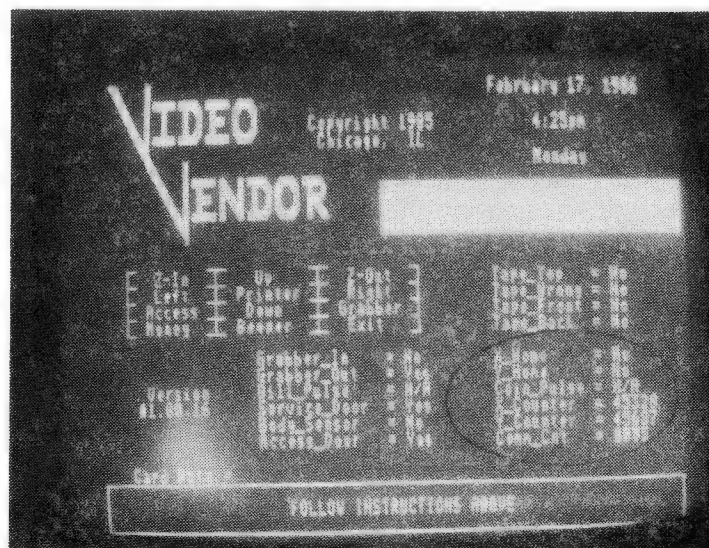
PHOTO (1)

DISPLAYED ON THE SCREEN WILL BE ALL OF THE ENCODER INFORMATION WE WILL NEED TO TEST FOR X-HOME AND Y-HOME CONDITIONS AND FAULTS.

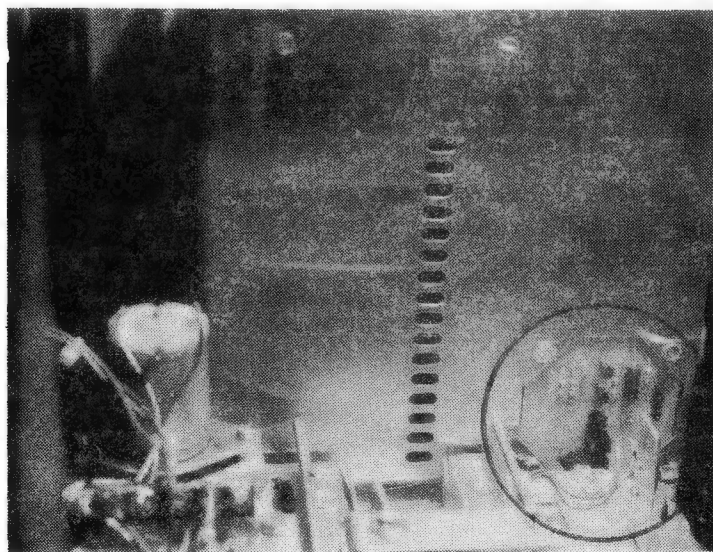
PHOTO (2)

BEFORE BEGINNING THE INTERRUPTER TESTS AS DESCRIBED BELOW MAKE CERTAIN THAT THE PLASTIC INTERRUPTER IS IN FACT ENTERING THE BLACK -U-SHAPED HOME ENCODER. [SEE PHOTO (2)] . TO VIEW THE X-HOME ENCODER IT IS USUALLY NECESSARY TO REMOVE THE TAPE CARRIER TRANSPORT COVER IN ORDER TO SEE THE INTERRUPTER ENTER THE BLACK INFRA-RED HOME DETECTOR...BUT...WHEN YOU REMOVE THE COVER THE SYSTEM MAY NOW APPEAR CORRECT; THAT IS THE PLASTIC INTERRUPTER ENTERS THE U-SHAPED DETECTOR, WHEN YOU PUT THE COVER BACK ON THE SYSTEM FAILS....CAREFUL EXAMINATION MAY SHOW THAT THE INTERRUPTER IS JUST BARELY ENTERING THE LOWER EDGE OF THE HOME DETECTOR WITHOUT THE COVER ON. THE ADDED WEIGHT OF THE COVER AND A TAPE LOWERS THE ASSEMBLY JUST ENOUGH TO CAUSE THE INTERRUPTER TO HIT THE DETECTOR AND BE DEFLECTED ...SOLUTION---MAKE SURE THE INTERRUPTER ENTERS THE CENTER OF THE DETECTOR. CAUTION; DO NOT BEND THE PLASTIC INTERRUPTER TO MAKE THE ADJUSTMENT. THE ENCODER BOARD IS MOUNTED WITH 4-SCREWS AND THEY ALLOW FOR VERTICAL ADJUSTMENT. LOOSEN THE SCREWS SLIGHTLY AND PRY GENTLY UP OR DOWN ON THE BOARD EDGE TO SHIFT THE BOARD TO THE REQUIRED POSITION.

showing the plastic interrupter entering the x- home encoder

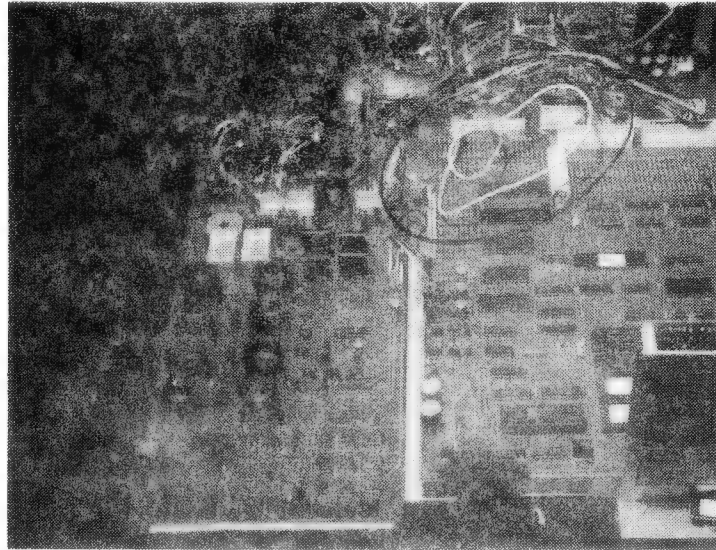
PHOTO (5)

showing pins #1 and #8 jumpered together on the J4 connector

IF THE DISPLAY NOW SHOWS -NO THEN YOU WILL HAVE TO LOOK FOR A SHORT TO GROUND IN THE CABLE SET. IF THE DISPLAY WAS CONTINULY SHOWING -NO THEN TRY SHORTING THE 1ST AND 8TH PINS TOGETHER SEE PHOTO (). THIS SHOULD PRODUCE A -YES- ON THE DISPLAY IF IT DOES THEN THE PROBLEM IS IN THE CABLE YOU WILL HAVE TO LOOK FOR A DEFECTIVE CABLE...BROKEN LEAD OR MORE LIKELY A BAD CONNECTION IN ONE OF THE PLUGS. IF THE DISPLAY STILL DOES NOT SHOW YES THEN THE PROBLEM LIES IN THE MAIN PROCESSOR BOARD.

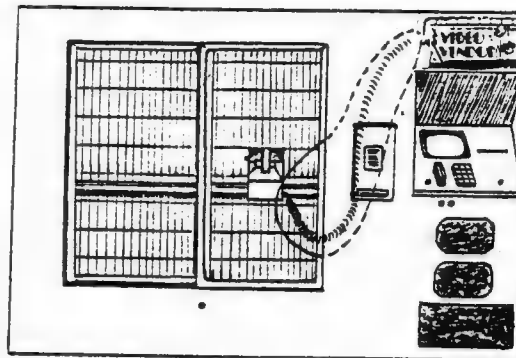
The long coiled cord used on the tape transport can get jammed at the access door, under certain conditions, and cause the Vendor to blow the fuse on the motor controller board. It would be beneficial to check the cords on all Vendors and correct the hanging of the cord if it is found to be incorrect.

The connection at the retriever end of the cord should be made as shown in FIG. 5a. If it is connected as in FIG. 5b, remove the transport cover, loosen the cord clamp, turn the cord to the proper position and retighten the cord clamp.

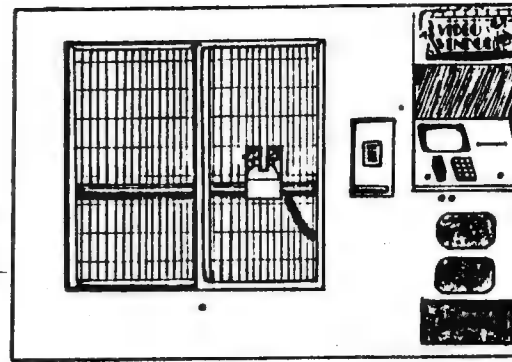
This bulletin is to alert you to what we have found to be a primary cause of coiled cord problems.

Whenever the retriever is removed from the horizontal rail and turned upsidedown for repairs, it is possible that turning the retriever over again could cause tangling of the coiled cord. For example, while adjusting or replacing the grabber motor drive belt (See Service Bulletin #2) care should be taken not to rotate the retriever before reattaching it to the horizontal rail. Rotating the retriever twists the coiled cord and will cause a jam at the access door.

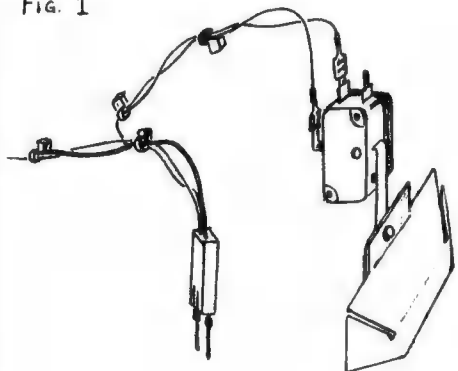
This mechanical sensor is replaced by an improved, infra-red tape top sensor.

This new, solid state switch eliminates the mechanical adjustment occasionally required due to customer tampering. If you wish to replace your mechanical switch (FIG. 1) with the new one, the connecting cable (included) will also need to be replaced, involving some soldering. The cost of the kit is \$44.79, part # K-3057.

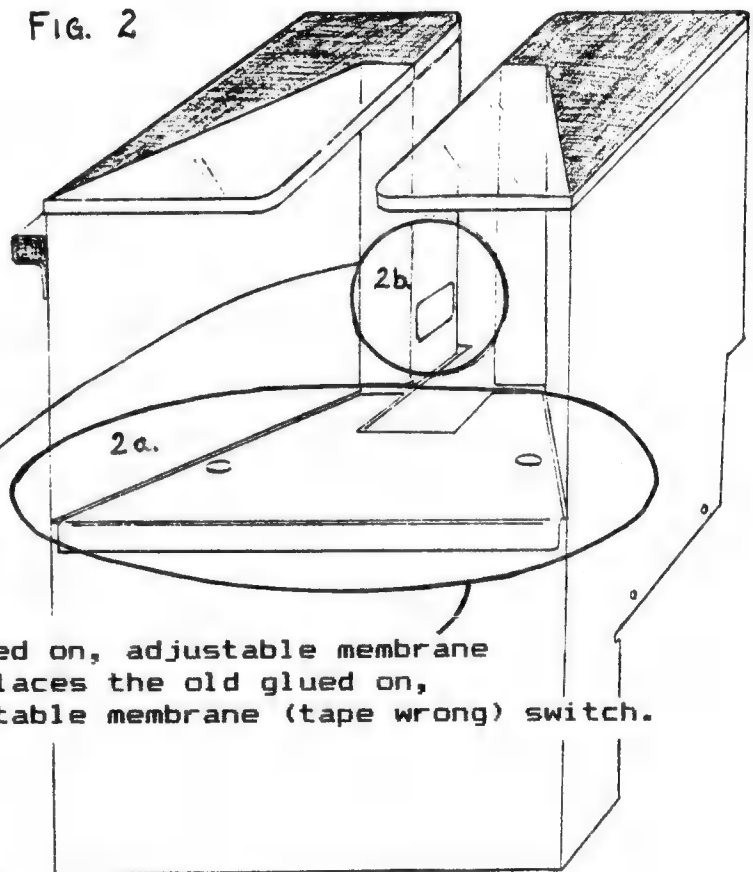
New, bolted on, adjustable membrane plate replaces the old glued on, non-adjustable membrane (tape wrong) switch.

We have found that the switch is almost indestructable, but because you could not adjust its sensitivity in the field to compensate for rough treatment by customers, it could fail.

This switch is now made as a bolted assembly (FIG. 2a) instead of a glued one, allowing field adjustments to correct for failures. However, if your switch has operated for the past three months or more with no problems, we DO NOT recommend changing it.

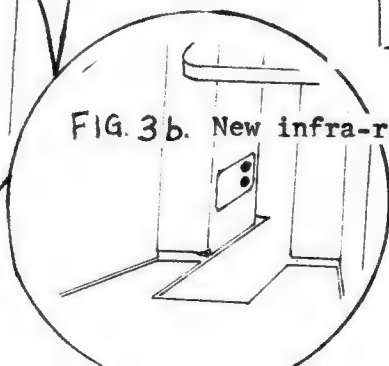
FIG. 3b. New infra-red sensor

Either the mechanical sensor or the infra-red solid state sensor with the LEDs in the position shown in 3a (closest to the lexan doors), should be replaced with the newest version of the tape top sensor. It has LED (light emitting diode) sensors in the position shown in 3b (closest to the tape shelves).

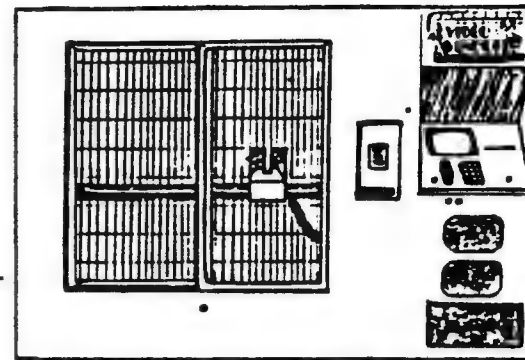
FIG. 1

We have noticed that the Title Labels on the spines of cassettes can begin to peel up (See FIG. 1) and can cause retriever "Error 99" problems.

It usually occurs while the retriever is returning a tape. As the grabbers slide the tape back on the shelf, the exposed sticky area on the upturned Title Label or on the cassette sticks to the grabber (See FIG. 2). When the grabber retracts, the cassette is pulled partially back into the retriever. If the cassette blocks the Tape Front and Tape Top sensors, the computer interprets as a tape jammed in the transport. You get an "Error 99" indicating either Tape Front or Tape Top as the problem. If the tape is pulled out, but not far enough to block the sensors, the retriever in motion may hit the protruding cassette and cause a jammed condition. The result of the jam could be a tape jammed sideways between the retriever and the tape cabinet or you may find a tape on the floor of the wooden cabinet with no explanation for why it's there.
